**CASE STUDY**

<b>Case Study:</b>	<b>Brann Football Stadium, Bergen, Norway</b>
<b>Contracted by:</b>	<b>Mastercare AS</b>
<b>Application:</b>	<b>Lightweight / Fire-Retardant Spray Concrete</b>
<b>Requirements:</b>	<b>Fire-Retardant Coating to Underside of Wooden Stadium Roof</b>
<b>Solution / Product:</b>	<b>LightCem® FIRESHIELD®™</b>

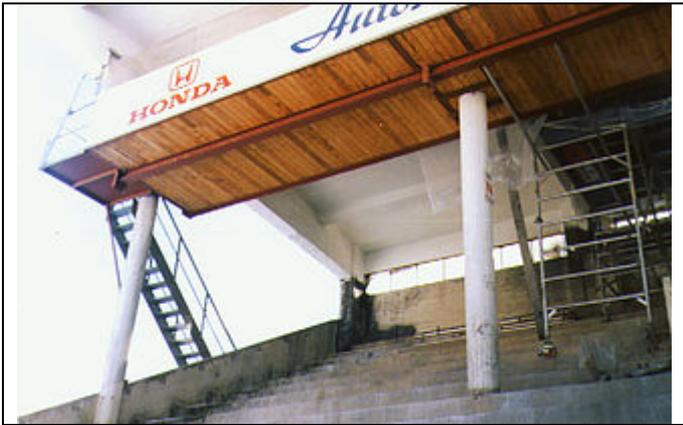
**THE PROBLEM** When pieces of concrete began to break free from the underside of the cantilever roof at Brann Stadium, the Norwegian authorities had no choice but to close the building. Engineers subsequently reported that the steel reinforcing suffered from inadequate coverage and that large areas of the concrete were already "blown" and likely to fall on the seats below. The report made it clear that not only would the repairs be both difficult and time consuming, but additional structural supports would be required just to carry the extra weight imposed by the repairs.

**Brann Stadium Canopy Roof** Old concrete and cement was stripped off.

**THE SOLUTION** Removing all loose and "blown" concrete. Sand blast exposed reinforcing along with the complete underside of the cantilever roof. Using wet-spray method apply Lightcem's FIRESHIELD to the entire area strengthening the steel and wooden structure and adding fire protection to the wooden components of the structure.

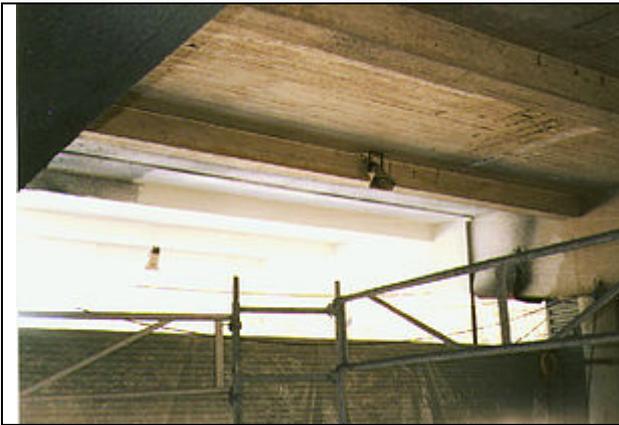
**Brann Stadium Canopy Roof** Old cement was replaced with sprayed on LightCem FIRESHIELD.

**The Result** A cost effective solution, with the minimum of fuss and the shortest possible shutdown period. It was completed by the addition of white cement to the FIRESHIELD formula, leaving the stadium looking light, bright and brand new, structurally repaired and fire resistant.
